# **Official Transcript of Proceedings**

## **NUCLEAR REGULATORY COMMISSION**

Title: Advisory Committee on Reactor Safeguards

Plant License Renewal Subcommitee Prairie Island Nuclear Generating Station

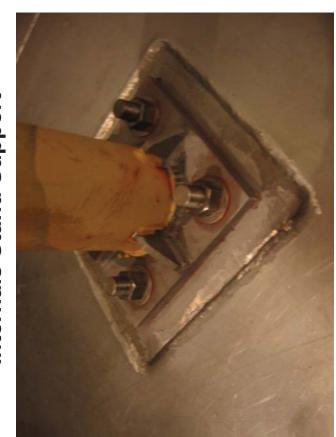
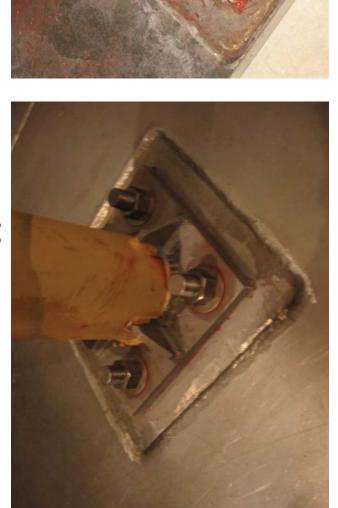
Typical Reactor Vessel Internals Stand Support

As a result of that root cause evaluation, we determined the sources of leakage to be the embedment plates for the reactor internal stands which are in the lower cavity and then the rod control cluster change fixture supports which are in the transport.

The leakage, we believe to be flowing the threads down past the nut. Once past the nut, there's a seal weld -- this is the RCC change fixture -- seal weld that was installed when this was originally put in.

That ground flush, we believe that there's a leakage path to that location that's allowing the refueling cavity water then to pass completely through the stud and then come out underneath the embedment plate.

We'll also be putting a seal weld between the base plate and the embedment plate to eliminate that leak path.

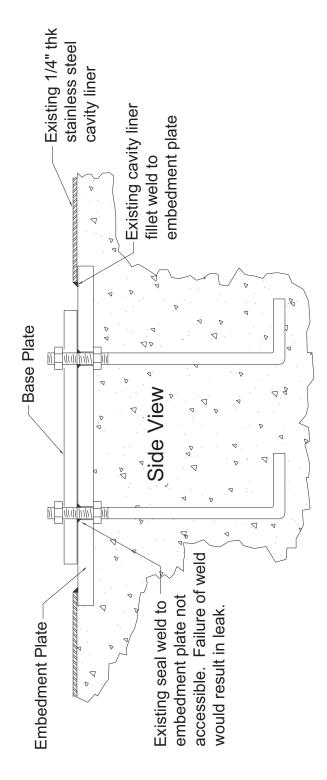
#### Refueling Cavity Leakage -eak Locations

The cumulative leak rate that we see from the refueling cavity is approximately one to two gallons per hour. It's most commonly seen in the ECCS sump and then in the regenerative heat exchanger room.

Once the leakage is underneath the refueling cavity and liner -- or seeped through -- it will travel through construction joints between the floor of the transfer pit and the wall behind the transfer tube. Once it's behind the wall in the

We have also seen evidence of leakage in our regenerative heat exchanger room, which is directly below the lower refueling cavity. That particular leakage will travel and once it's underneath the liner. It can follow hairline cracks in the concrete and then seep through the sealing in the walls in that particular room.

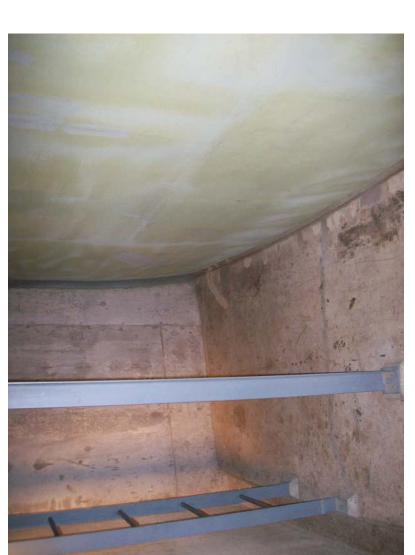
## Shield Building Annulus

annulus was performed.
Scanned 18' long x 2' high area with all readings above 1.5 inch nominal plate thickness. UT exam of containment vessel from

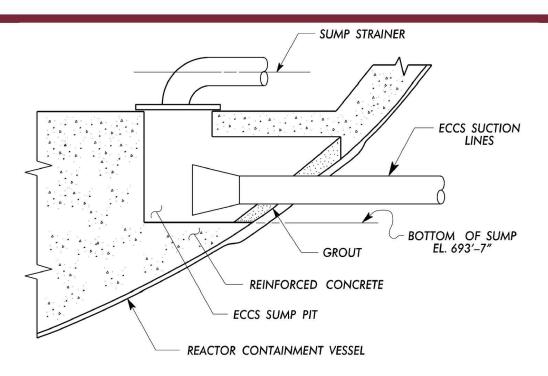
#### **ECCS Sump Showing Grout**

There is evidence of leakage in the sump under the reactor vessel only in that there's a stain in the wall that originates from a construction joint and comes down the wall. Actual leakage has never been witnessed because that sump is not accessible when the pool is flooded.
